DOCUMENTS TO THE REQUESTOR  
EPA-R5-2015-000396

L0316485024 - Cook Co.  
Sun Machine Parts & Tooling  
ILD# 001994722  
SF/HRS

# **CERCLA Abbreviated Preliminary Assessment**

The Superfund Technical Assessment and Response Team (START) of Ecology & Environment, Inc. (E & E), was tasked by the Enforcement and Emergency Response Branch (EERB) of the United States Environmental Protection Agency (U.S. EPA) to conduct a site assessment at the Sun Machine Parts site in Chicago, Cook County, Illinois, under Technical Direction Document (TDD) S05-9701-003. START was tasked to prepare and implement a health and safety plan; compile and review background information; subcontract analytical services; document conditions at the site; conduct air monitoring and multi-media sampling; evaluate threats to human health and the environment; and make recommendations and provide options to U.S. EPA as to the potential need for a removal action, further investigation, referral to other government agencies or U.S. EPA programs, or other actions which may be prudent. The site assessment was performed in accordance with the National Contingency Plan (NCP) in the Code of Federal Regulations (CFR) Secti

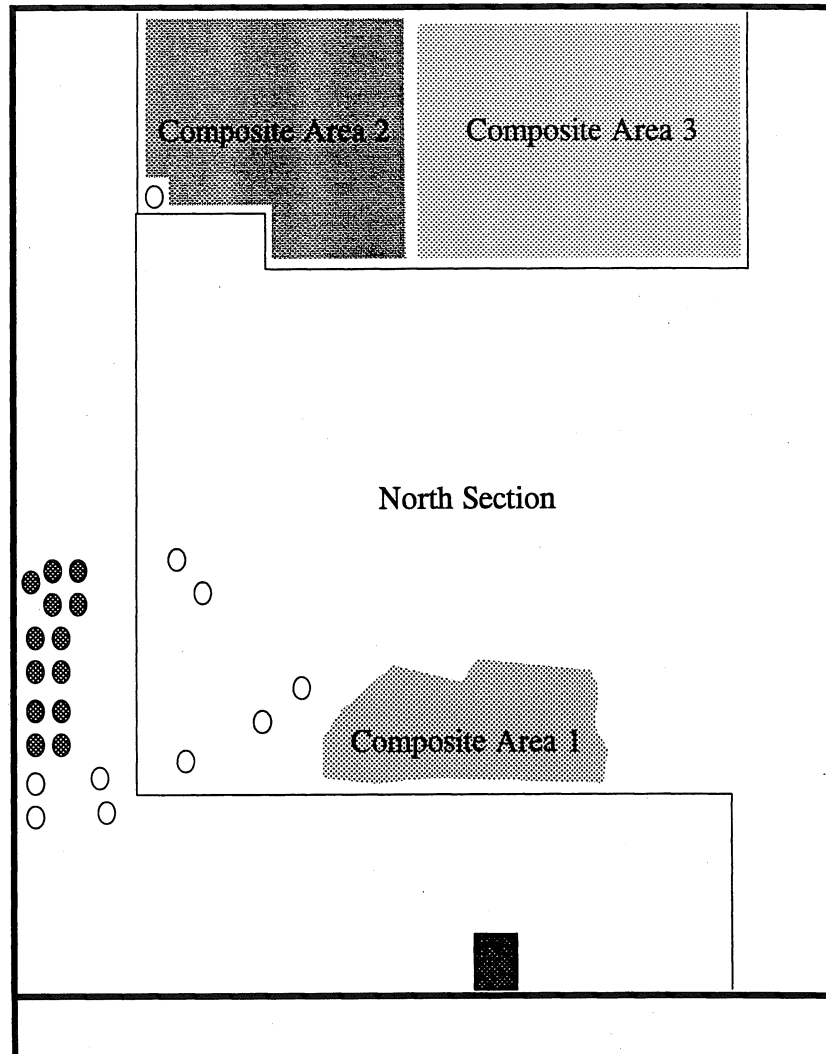
TITLE	Site Features Map	FIGURE #	3-1
SITE	Sun Machine Parts	SCALE	Not to scale
CITY	Chicago	STATE	Illinois
SOURCE	Ecology & Environment, Inc.	TDD #	S05-9701-003
		DATE	1997
		REVISED	NA

A significant amount of surface staining was observed in the north section of the building. Three composite soil samples were collected from this area. Composite sample S-1 was collected from an area of dark black staining with a significant amount of scattered miscellaneous debris. Composite samples S-2 and S-3 were collected, adjacent to each other, from areas of brilliant, colorful staining on an elevated pad in the north area of the north section of the building. All soil samples were analyzed for semivolatile organic compounds (SVOCs), Resource Conservation and Recovery Act (RCRA) metals, and cyanide.

A total of three drum samples were collected from 55-gallon drums in the north section of the building. Drum sampling was conducted in Level B personal protective equipment, with continuous air monitoring. Drum sample D-01 was collected from a 55-gallon drum of what appeared to be brown paint. No "flammable" labels were noted on the drum. The highest reading with a photoionization detector (PID) in the headspace of the drum was approximately 2,000 parts per million (ppm). Drum sample D-02 was collected from a 55-gallon drum which was labeled as a "flammable liquid". The PID reading in the headspace of the drum was approximately 500 ppm. The contents of the drum appeared to be green paint. Drum sample D-03 was collected from another 55-gallon drum which was labeled as a "flammable liquid". The PID reading in the headspace of the drum was approximately 500 ppm. Its contents appeared to be gray paint. All drum samples were analyzed for pH, flash point, volatile organic compounds (VOCs), SVOCs, and RCRA metals.

During the site investigation, START noted the presence of several capacitors on the floor in the south section of the building. The manufacturing date of these capacitors could not be determined. It is likely, given their condition, that the capacitors contain PCBs, which are regulated under the Toxic Substances Control Act (TSCA) and require special disposal.

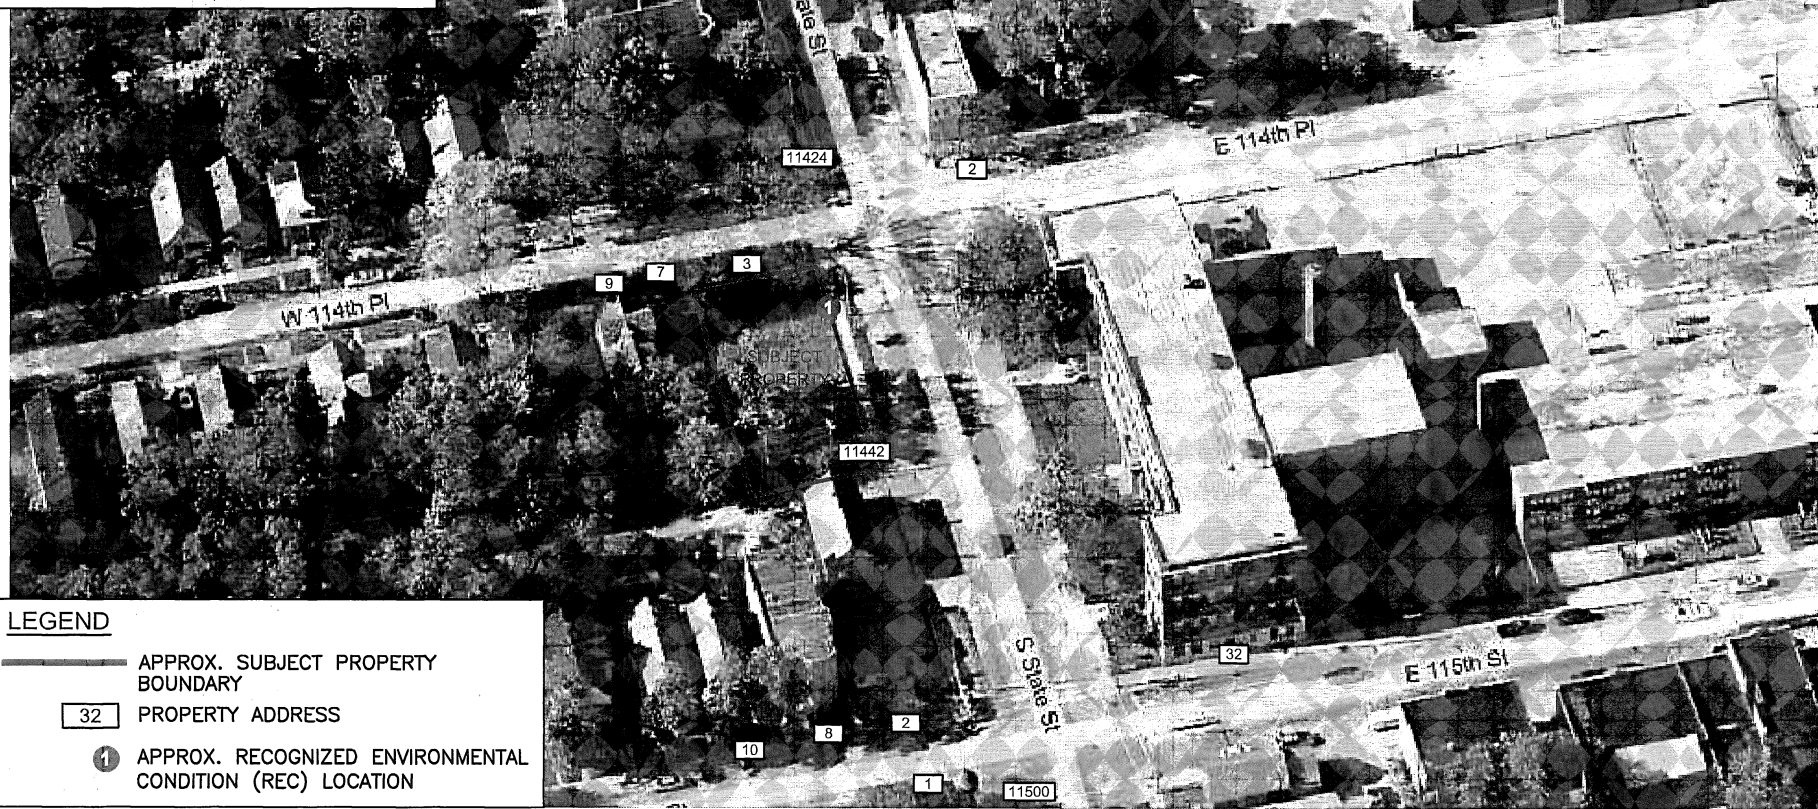
## SUMMARY OF PHASE I ESA RECOGNIZED ENVIRONMENTAL CONDITIONS

REC #	LOCATION	ISSUE / CONCERN / COMMENTS
1	General Property	Urban Soil - Based on the urban setting of the Subject Property, former development, demolition and potential placement of fill on the Subject Property, and Shaw's experience with similar sites in the region, a potential exists for the urban soil/fill to contain polynuclear aromatic hydrocarbons, total lead and arsenic constituent concentrations at levels above regulatory ingestion exposure route standards. There is a lack of qualitative soil data relative to urban soil/fill on the Subject Property.
